RECOVERY BOILER GENERATING BANK TUBE THINNING

David G. Stasuk, P.Eng.

Stasuk Testing & Inspection Ltd.

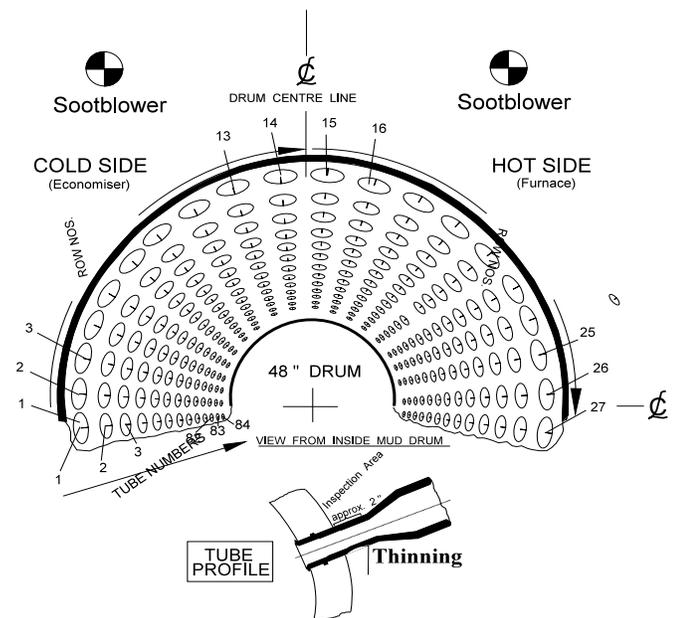
Black liquor chemical recovery boilers, such as those used in the kraft pulping process, typically utilize a steam generating bank with a multitude of closely spaced vertical tubes connecting an upper steam drum and a lower mud drum. **Figure 1** shows a typical lower drum tube layout with the usual thinning location.

It has been ascertained that the failure of almost all of the tubes in the generating bank is caused by thinning of the tube wall where it leaves the lower (mud) drum, within the first 2 inches. This has been observed in both swaged and non-swaged tubes. There can be from 700 to 3000 tubes in a generating bank, usually spaced approximately five inches apart.

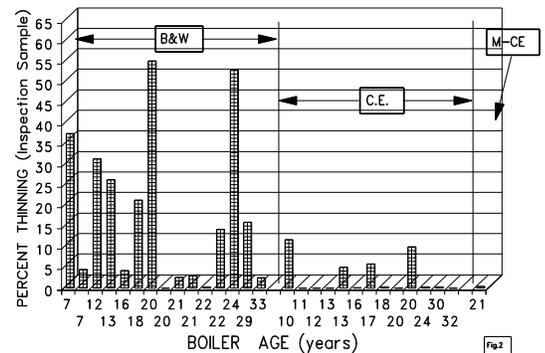
Figure 2: % THINNING vs. BOILER AGE

Figure 2 is a bar chart which shows a comparison of tube thinning with boiler age. The boiler manufacturers are grouped separately to show if there is a correlation between design and age. The height of each bar represents the percent thinning of the actual sample tested, not the percent of the total tubes in the generating bank.

- (4) The B&W boilers seem to have a more severe thinning problem than the C.E. units tested to-date.
- (5) There does not appear to be a correlation between boiler age and thinning. Boilers as new as 7 years and as old as 29 years both show significant thinning. (Note: some data has been collected on boiler rebuilds as new as 4 years which are starting to show signs of thinning).

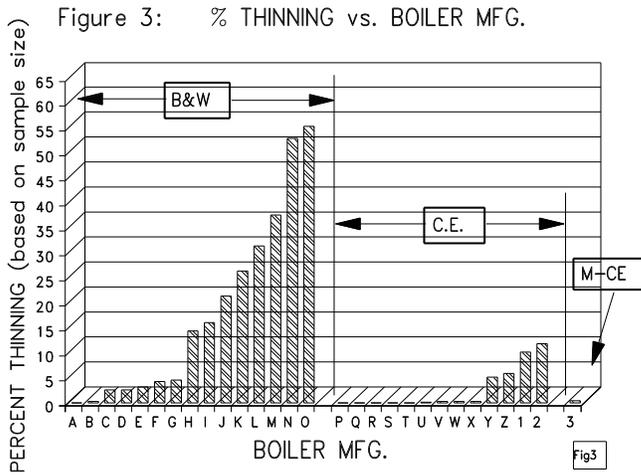
Figure 3 is a bar chart which shows a summary of boilers inspected, again grouped according to manufacturer. Boiler designations A through O are B&W, P through 2 are C.E. and boiler 3 is a Mitsubishi-CE. Again, the height of each bar represents the percent thinning of the actual sample tested.

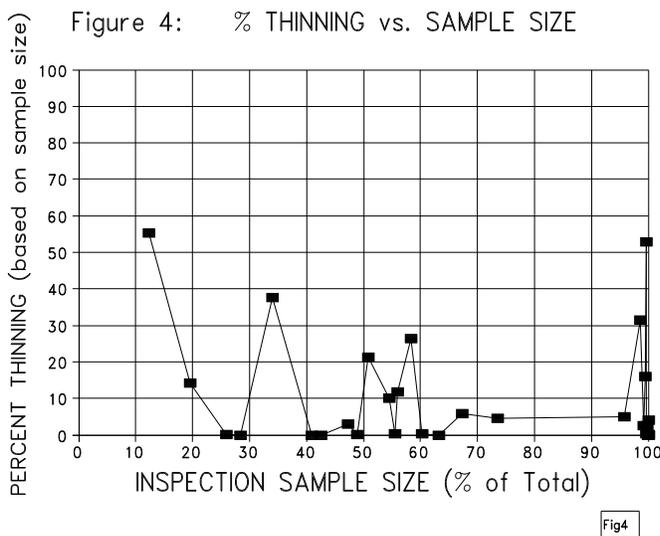
Figure 4 is a line graph which shows the relationship between observed tube thinning and test sample size. This was prepared to ascertain whether a minimum sample size could be established that would give a degree

of confidence in finding the majority of any thin tubes which may be present.

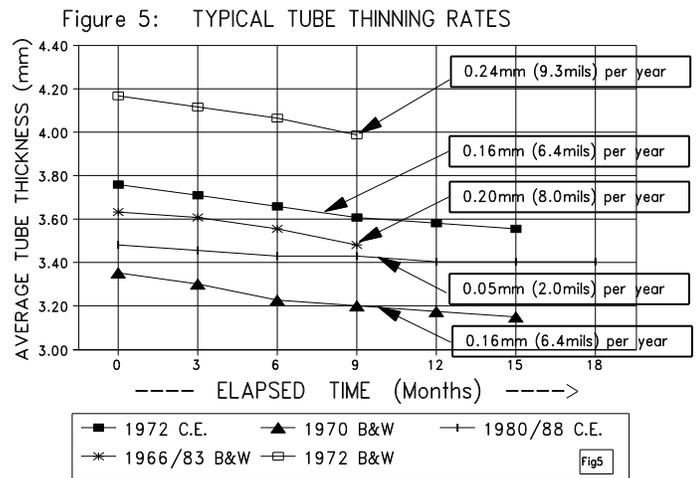
Figure 5 shows typical tube thinning rates for boilers that have had multiple inspections. The wastage rates show an average of 0.05mm (2.0 mils) to 0.24mm (9.3 mils) per year thinning. This is an overall average for all tubes inspected in the generating bank. In some cases, the wastage rate has been shown to be significantly higher when only the thinnest tubes are compared, instead of overall average tube thickness.

- (2) The corrosion mechanism is generally related to sootblower location as shown by the thinning patterns observed.
- (3) The wastage rates vary for different boilers with overall average rates from 0.05mm (2.0 mils) to 0.24mm (9.3 mils) per year.
